# “Treating” Treated Wood—Decks

Terry L. Amburgey and Kevin W. Ragon

SCH Report 8

2008

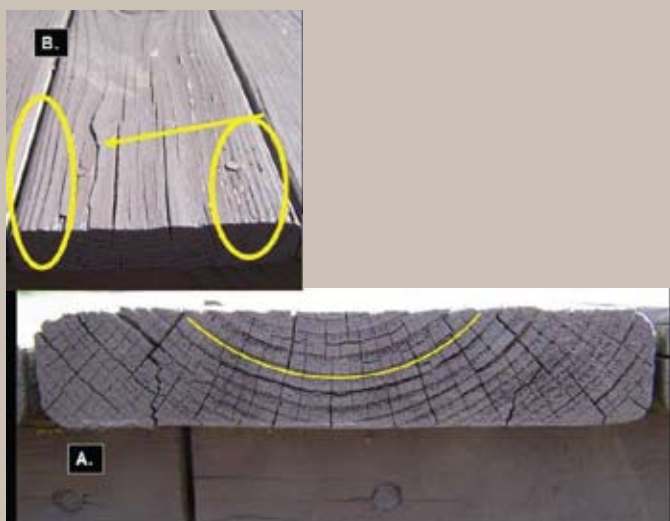
Figure 2. (A.) is a cross section of a painted decking board that has been installed with the grain orientation bark side down. (B) shows moderate raised grain (circled) and loosened grain (arrow). In unpainted wood these problems can lead to checking, splinters in bare feet, or tripping on the walking surface.

2. Decking components should be joined with fasteners compatible with the preservative system that was used to treat them, as discussed above.
3. Place decking boards with the “bark side up” (as discussed above) to avoid a “washboard” feel to the upper surface and to avoid splinters (Figures 1 and 2).

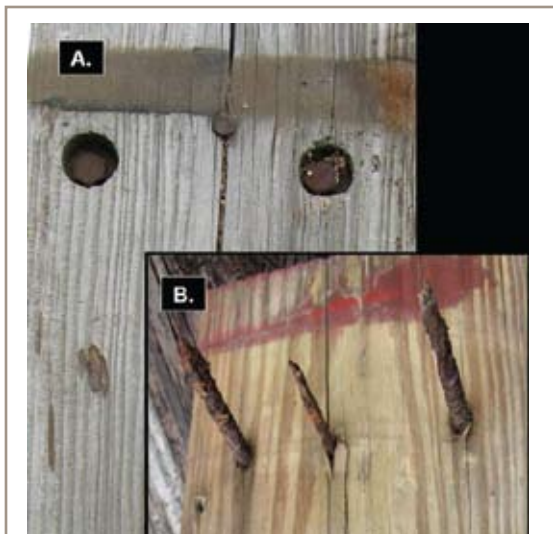
The types of fasteners used in deck construction are very important for maintaining the long-term durability of decks because wood of most species used in deck construction is acidic, and treated wood may contain chemicals that are corrosive to some metals. Since the preservative formulations used to treat decking are water-borne, wood treated with nearly all of them has little water repellency and can absorb water from rains, especially at the ends and at holes created by fasteners. Since moisture accelerates corrosion, water accumulating adjacent to fasteners assures that those fabricated from metals incompatible with the preservative system used will occur (Figure 3).

Figure 3. (A.) shows a top view of 3 ½ inch treated lag screws and a nail inside the decking, (B.) is the bottom view of the same board withdrawn from its support on a 28 year old deck. In (B.) the corrosion of the lag screws (no threads) and nail have allowed the decking to move freely on its supports which was common to the majority of the boards on the deck. Notice the splitting near the end grain where moisture is absorbed by wood and where fasteners are used for connection to the deck framing.

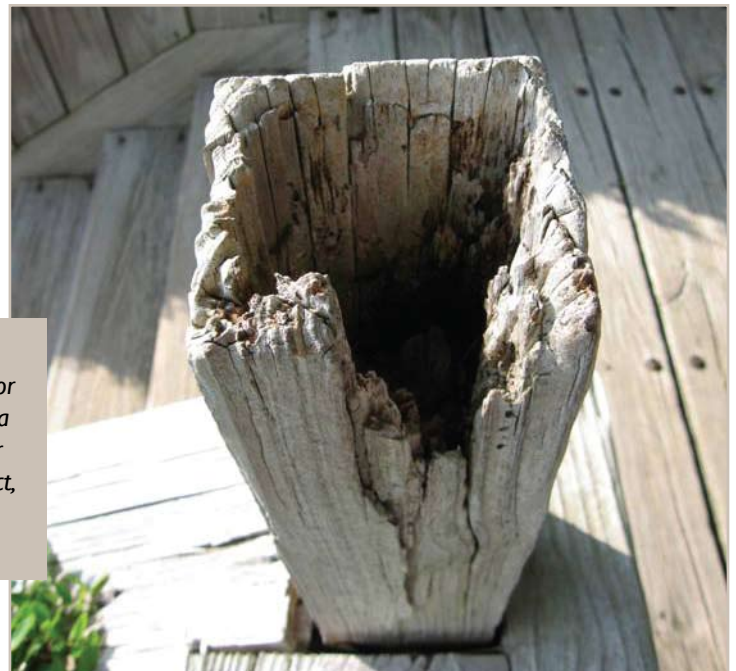
Figure 6. End grain of a CCA-treated southern pine support column from a deck exposed in AWPA Decay Hazard Zone 4 for 26 years that had been cut to size and not protected by either a supplemental brush-on preservative treatment or a cap to cover the freshly-cut surface. The outer treated sapwood remains intact, but the inner non-treated heartwood has decayed, necessitating replacement of the column.

the untreated heartwood will decay and the piece need to be replaced (Figure 6). Also, avoid placing the lower ends of columns directly into the soil and, as is frequently done, pouring cement around them. This practice traps water at the column bottoms and may lead to depletion of preservative and failure. Rather, either place them on raised concrete footings or pour concrete into holes where columns are to be placed, fill them to within a few inches (e.g., 12 inches or less) of the surface with concrete, allow the concrete to solidify, place the columns on top of the concrete, and fill the area around the columns with washed gravel. Ideally, the bottoms of the columns should be placed into a bucket of WRP for a minute or two before being put into place or treated with a ground-line preservative such as is used with utility poles (Figure 7). When ordering treated wood for use as columns, specify that materials are to be treated to ground contact retentions (tags on the material should indicate that it is treated for use in ground contact) (Use Categories UC4B or UC4C as specified in the AWWPA Book of Standards) (2).

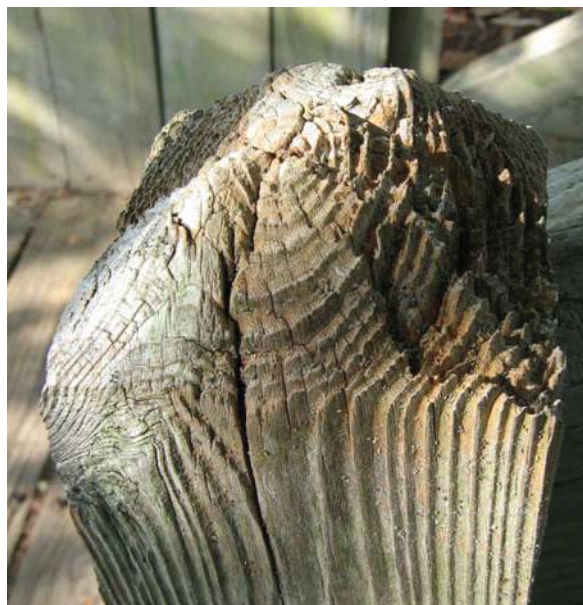
Figure 10. In contrast to the post shown in Figure 6, this post on the same deck was cut at the top to shed water and experienced much less decay.

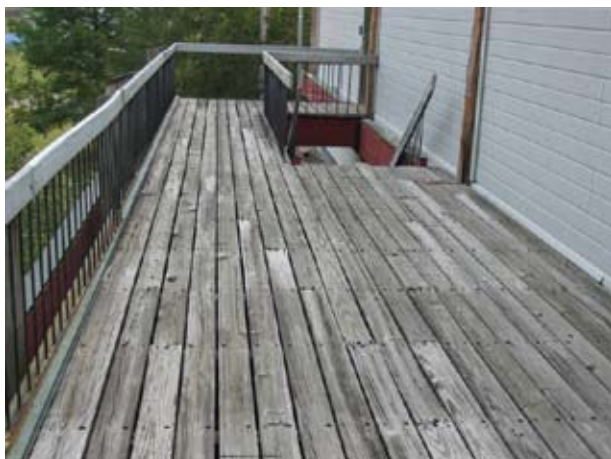
The walking surface of the deck (Figure 13) at first glance shows extreme graying from UV exposure, warping, checking, and splitting giving the impression that the boards were decaying. The wood had been exposed to an average annual rainfall of 52 inches (1456 inches total) and an average temperature of 640F (180C), (high 770F (250C) and low 520F (110C)) (8, 14, 15). These exposures, with no added WRP, resulted in checking and splitting, especially near the end grain, and accelerated the corrosion and subsequent failure of the mild steel fasteners (Figure 13). It was estimated that over 30% of the fasteners that held the sills, decking, and railing in place had corroded and were no longer functional. One decking board that had a section of heartwood showed signs of decay during its removal, a consequence of no supplemental maintenance treatments (Figure 14). The appearance of the walking surface, the feel of walking on loose boards and the decay seen in the untreated heartwood section on an initial inspection could indicate that the decking was unsound, but further inspection indicated just the opposite. Figure 15 compares the walking surface to the bottom surface of the decking, indicating that the biological degradation of the wood was less than 1% of the total deck. Observing the bottom surface of the deck boards you could guess that the 28 year old wood was 3-5 years old until you looked at the walking surface. Figure 16 shows this comparison with the bottom surface. Although one split penetrates to the bottom side, the lower surface is free of checks and graying; the wood is sound. It is reasonable to believe that with periodic supplemental WRP treatments the deck would not have been replaced.

Figure 13. A 28 year old CCA-treated southern yellow pine deck exposed in AWPA Decay Hazard Zone 4 that had no supplemental maintenance treatments.

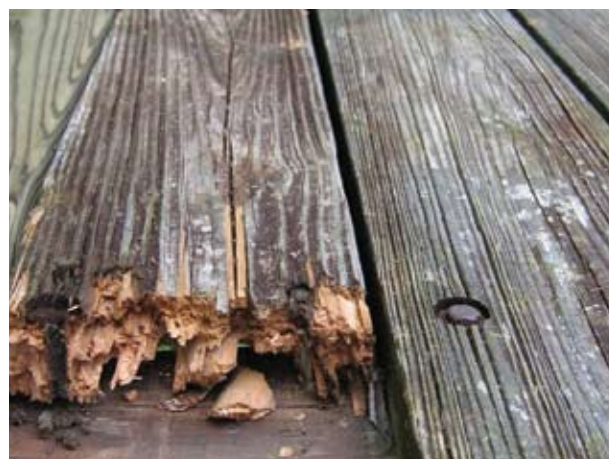
Figure 14. A decking board that had a section of heartwood that showed signs of decay during its removal, a consequence of no supplemental maintenance treatments.

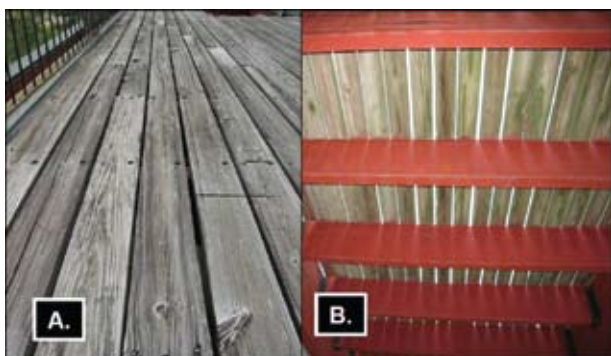
Figure 15. The top (A) and the bottom (B) horizontal surfaces of the deck in Fig. 13. The upper surface (A.) is characterized by discoloration, splitting, checking, cupping, warping and loose boards resulting from failure of fasteners whereas the bottom surface (B.) looks essentially new.

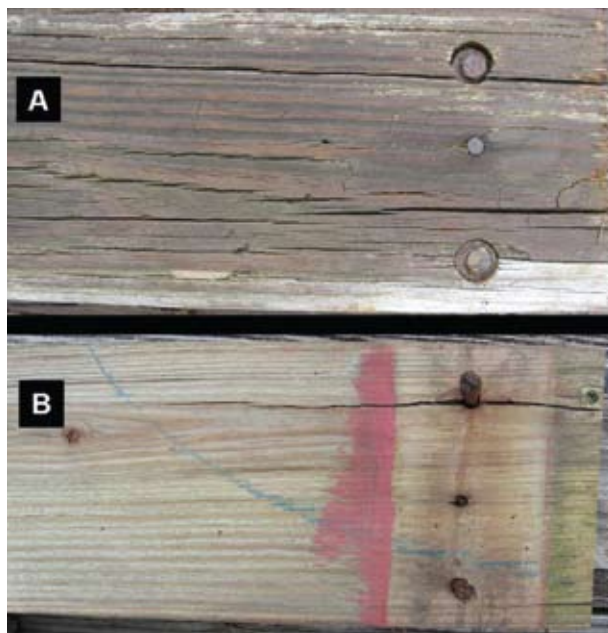
Figure 16. The top (A) and bottom (B) surfaces of a deck board removed from the deck in Fig. 13. (B) shows that the fasteners (lag bolts and screws) were deteriorated but the wood looks good except for one split that originated from a check on the upper surface. The bottom side indicates that, if protected from weathering, treated wood will deteriorate very slowly.
